ST PATRICK'S 10YEAR VISION & DEVELOPMENT PLAN

A SHORT SYNOPSIS

ST. PATRICKS RC CHURCH OLDHAM
Reaching Out – Our 10 Year Vision and Development Plan.
Adopted at AGM 27 June 2010

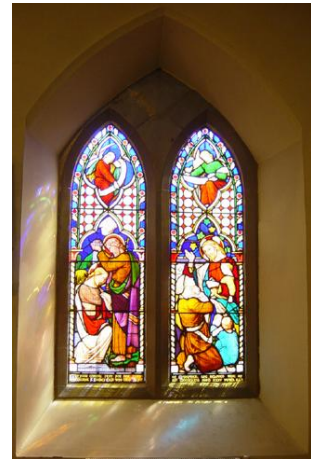
Baptistry Windows

Baptism and blessings depictions.
Dedicated to Margaret the beloved wife of
George A. Kingsley. died 3 Sept. 1869, 35 years.

The four stained glass windows in the south elevation (Baptistry and Polish windows) as part of their recent commissioning and installation have had the external polycarbonate sheeting and guards replaced by a system recommended by the Historic Church Commission.

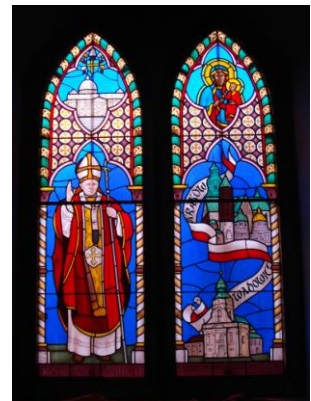
Polish Windows

Pope John II and Our Lady of Czestochowa,
Krakow depictions,
Donated by Oldham Polish Community, 2008
